# Manhole Inspection Summary

Manhole # S41M\_\_002MH

Insp Date: **7/31/08 2:58 PM**

**Location** Address: **701 S Eden St**

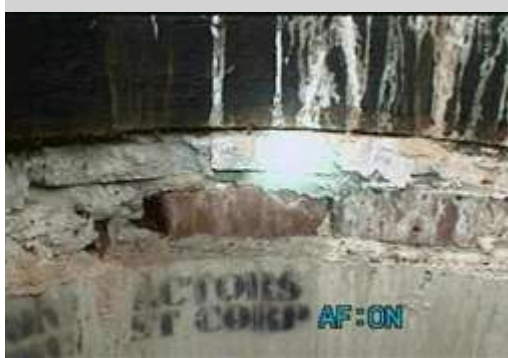
Defect 4

Condition: ☐ Sound ☒ **Cracked** ☐ Root Intrusion ☒ **Loose Brick** ☒ **Deteriorated**

Chimney\_Crack\_Loose brick

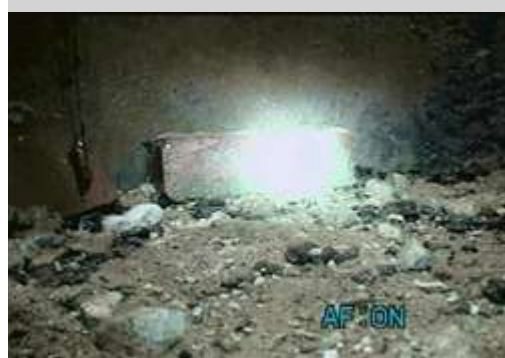
Defect 3

Condition: ☐ Sound ☐ Cracked ☐ Root Intrusion ☐ Deteriorated ☐ Leaks ☒ **Debris**

bench debris

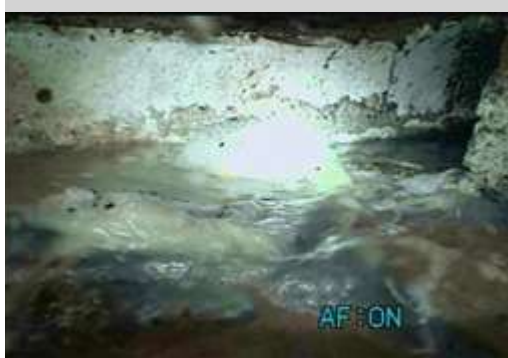
Defect 2

Condition: ☐ Sound ☐ Cracked ☐ Root Intrusion ☐ Deteriorated ☐ Leaks ☒ **Debris**

channel debris

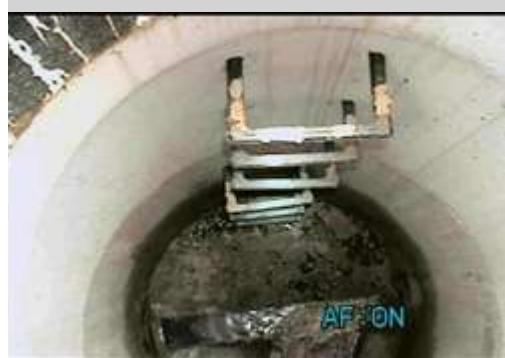
Defect 1

Count: **6** Missing: **0** ☒ **Corroded**

steps

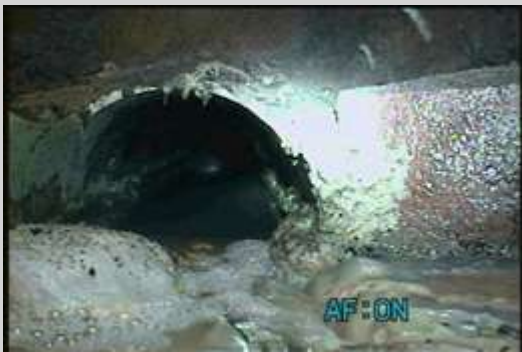
12 O'Clock Outflow

8 in. Circular Gravity Sewer  
Pipe Out @ 12 O'Clock

Pipe Material: **Clay** ☐ Pipe Lined

Invert Depth: **9.16** (ft.) Flow Characteristics: **Slow**

Infiltration: **None** Pipe Seal Cond: **Unknown**

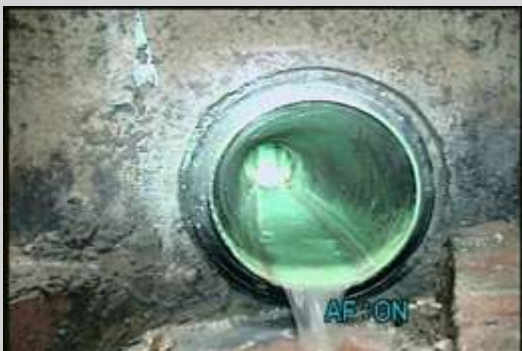
3 O'Clock Inflow

10 in. Circular Gravity Sewer  
Pipe In @ 3 O'Clock

Pipe Material: **PVC** ☐ Pipe Lined

Invert Depth: **8.96** (ft.) Flow Characteristics: **Slow**

Infiltration: **None** Pipe Seal Cond: **Unknown**

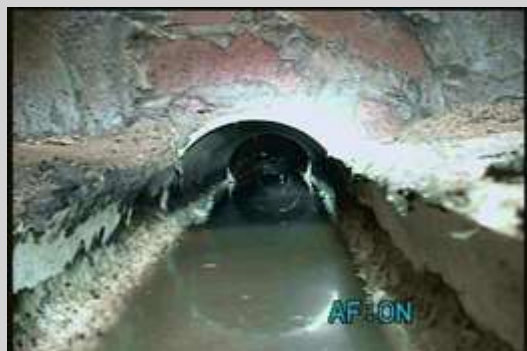
6 O'Clock Inflow

8 in. Circular Gravity Sewer  
Pipe In @ 6 O'Clock

Pipe Material: **Clay** ☐ Pipe Lined

Invert Depth: **9.00** (ft.) Flow Characteristics: **Slow**

Infiltration: **None**
